Maintainer

Issue 2/2004

Cross-Wired Side-Stick Almost Brings Down Airbus A320

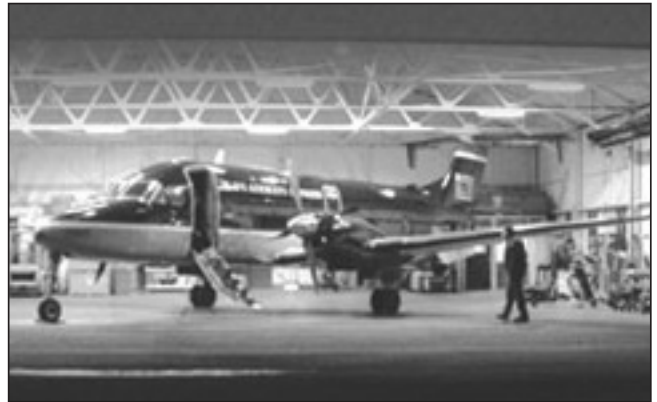
What maintenance action could have caused such a pitch change? Investigators were able to recover the elevator control system cables, elevator control rods, bell cranks, and elevator counter balance weights, all intact, from the wreckage. Examination of the elevator control cables revealed that the turnbuckle on the “down” elevator cable was offset to nearly full extension and the turnbuckle on the “up” elevator cable was near the fully retracted position, a difference of 1.8 in. The turnbuckles are used to set cable tension and are typically adjusted to about the same length. Through ground tests, which included a series of control column sweeps to collect data on the movement of the elevator and various cable tensions and turnbuckle lengths used during testing, investigators were able to reproduce similar conditions and obtain results that confirmed that the BE1900D had sustained a failure of its flight controls in pitch because of the incorrect rigging of the elevator control system. The extent of the loss of pitch control was further compounded by the airplane’s centre of gravity that was substantially aft of the certified limit. The accident occurred at the most crucial stage of flight and presented the most dangerous situation that a crew may be faced with; loss of elevator control authority following takeoff with an aft centre of gravity moment past maximum. “This accident shows how important it is for everyone involved in the safety chain to do their jobs properly,” said U.S. National Transportation Safety Board (NTSB) Chairman, Ellen Engleman-Conners. “It is imperative that the recommendations we’ve issued today be

Same aircraft type as in accident.
